# Manhole Inspection Summary

Manhole # S21G\_\_036MH

Insp Date: **8/27/07 11:19 AM**

**Location** Address: **1 MONROE ST**

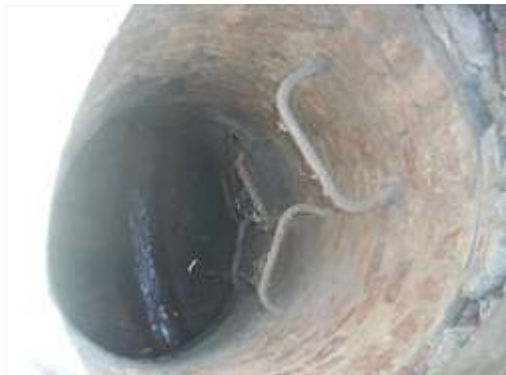
Defect 2

**Steps** Count: **5** Missing: **0** ☒ **Corroded**

CORRODED STEPS

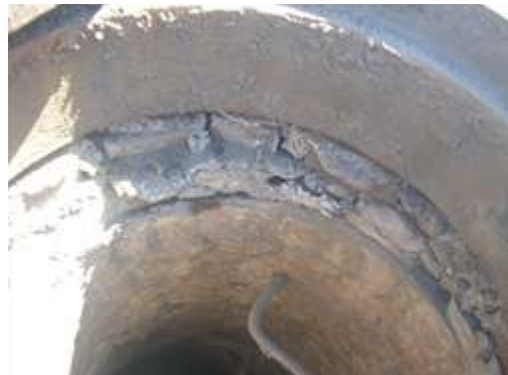
Defect 1

Condition: ☐ Sound ☐ Cracked ☐ Root Intrusion ☐ Loose Brick ☒ **Deteriorated**

DETERIORATION OF CHIMNEY

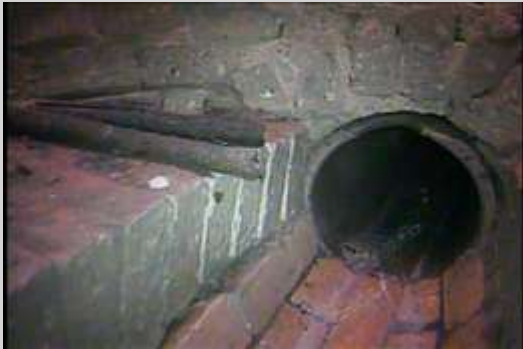
12 O'Clock Outflow

Pipe Height: **7.2** (in.) Rod and Bar (Angled)  
Pipe Material: **Clay** ☐ Pipe Lined  
Invert Depth: **9.40** (ft.) Flow Characteristics: **Slow**  
Deposits: ☒ None ☐ Mud ☐ Sludge ☐ Debris ☐ Grease  
Silt Depth: (in.) Deposits Extent:  
Infiltration: **None** Pipe Seal Cond: **Broken**

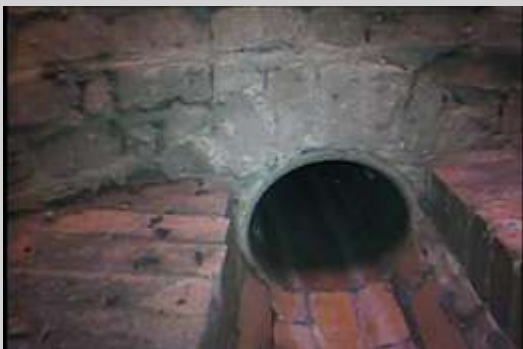
5 O'Clock Inflow

Pipe Height: **7.2** (in.) Rod and Bar (Angled)  
Pipe Material: **Clay** ☐ Pipe Lined  
Invert Depth: **9.26** (ft.) Flow Characteristics: **Slow**  
Deposits: ☒ None ☐ Mud ☐ Sludge ☐ Debris ☐ Grease  
Silt Depth: (in.) Deposits Extent:  
Infiltration: **None** Pipe Seal Cond: **Sound**
